REUSING STONES IN MEDIEVAL CHURCHES: A MULTIDISCIPLINARY APPROACH TO SAN MARTIÑO DE ARMENTAL (NW SPAIN)

Abstract

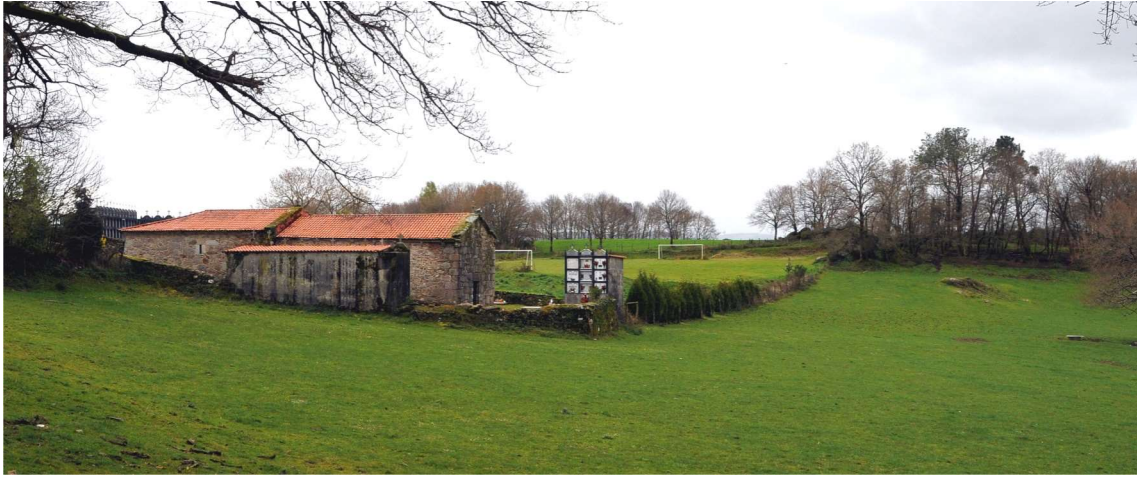
FIGURE 2

Fig. 2 View of the church from the North

San Martiño de Armental parish church is located in the village of A Eirexe (Vilasantar, A Coruña), some distance from the local houses, and 90 metres from the closest farm. It stands on a gently sloping hillside overlooking the valleys of *Rego do Bidueiro* and the *Río dos Muíños* (figure 2). The church has the ground plan of a basilica, with a rectangular nave and apse, separated by a buttress with a chamfered end section (figure 3). The apse is higher than the nave and is large, with almost the same dimensions as the nave, as it includes a sacristy adjacent to it (figure 3). It is oriented ESE-WNW and surrounded by a virtually oval wall made of irregular small-to-medium-sized stone blocks, alongside which are a number of niches and tombs that were added at a more recent date.

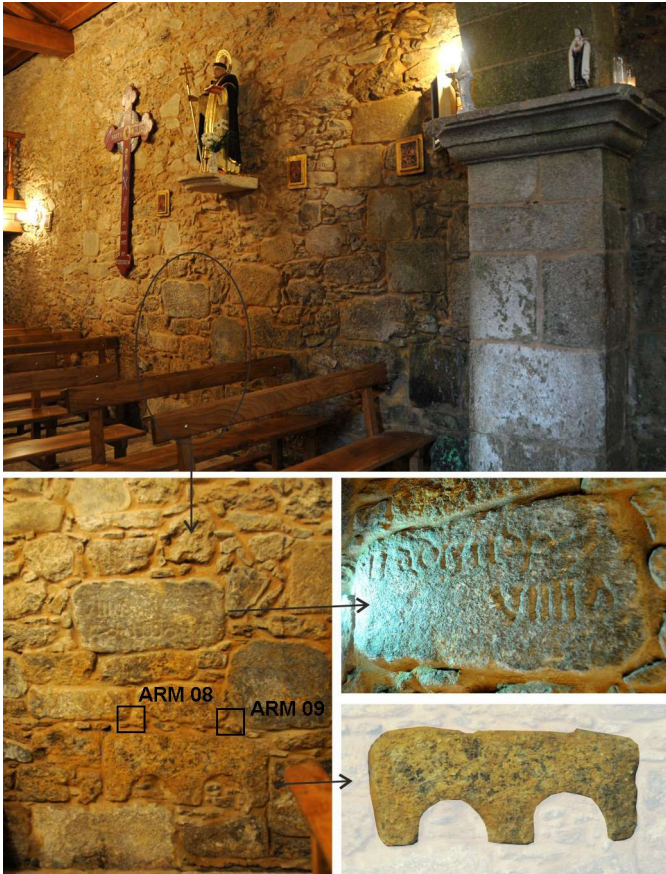
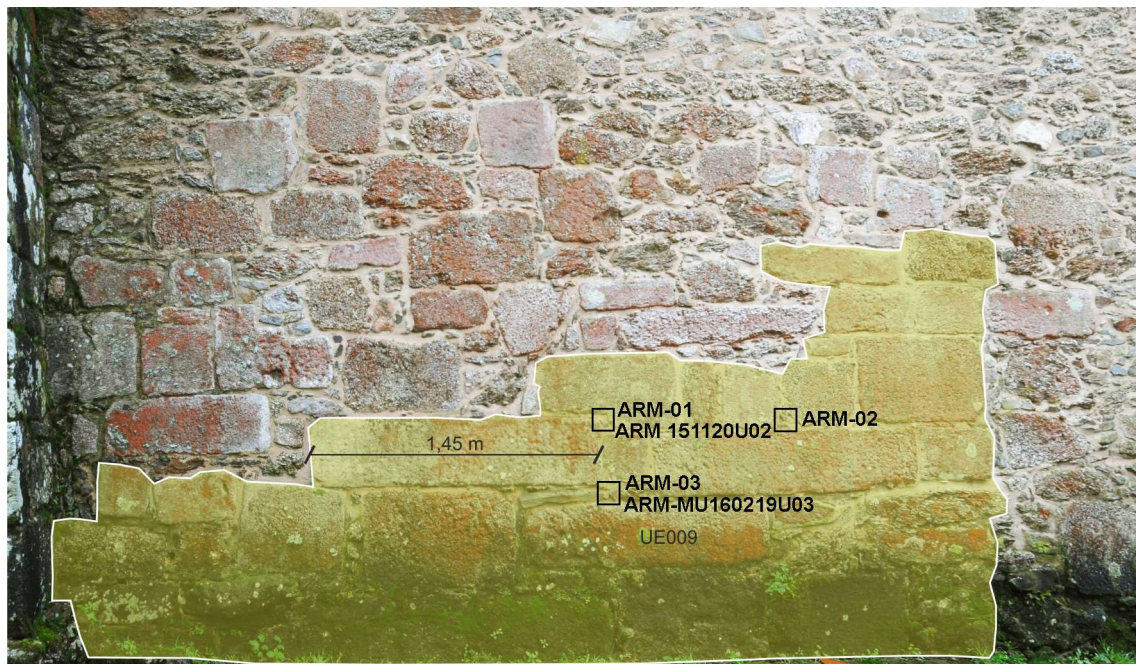
A total of 5 samples were taken for characterisation and Luminescence dating: 4 from mortars used in the joints, and 1 from a tile fragment for luminescence dating (figures 4 and 9). Three of the mortar samples were taken from the same wall (the exterior of the north wall: ARM-01, ARM-02 and ARM-03), while one was taken from the interior of the same wall (ARM-08), in the same zone from where the tile fragment was removed (ARM-09). Two additional mortar samples were taken from the same places in the outer wall for radiocarbon dating (ARM 151120U02, ARM-MU160219U03). All of the mortar samples taken for OSL dating were earth mortars. In order to take the samples, it was

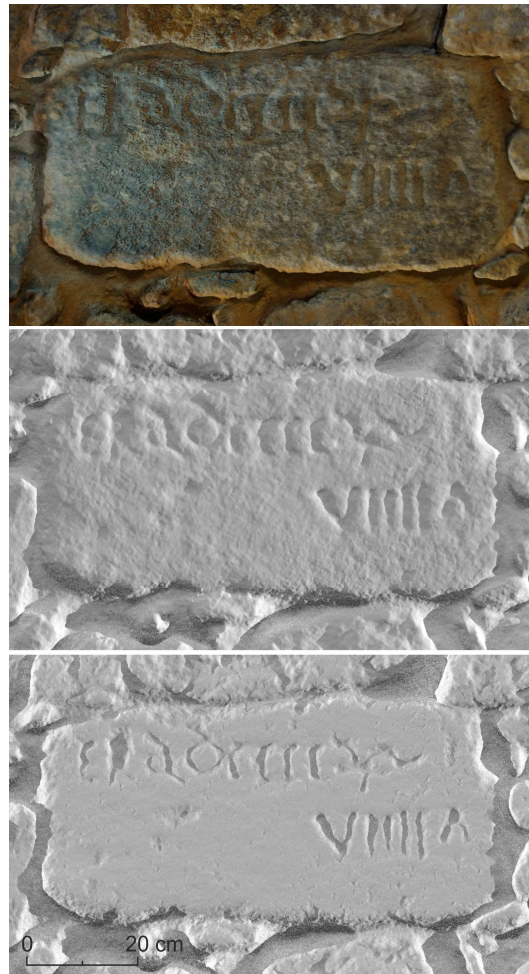
FIGURE 5

Fig. 5 Photogrammetric model of the epigraph discovered in the church, with and without texture and different digital illuminations in order to obtain a better reading of the inscription “Era DCCCC et VIII A(nnos)”. Model made with AgiSoft Photoscan Pro software

our attention was drawn to the presence of a number of ashlar accumulated in a part of its exterior northern end, which had nothing to do with the rest of the church's external walls (VVAA 2013: 150). In the interior of this same northern end we discovered an ashlar with an unusual inverted epigraph, showing the year 871 AD (+ERA DCCCC et VIIIA) (year 909 of the hispanic era), together with the upper part of a twin stone window, which are typical of the early middle ages in this part of the Iberian Peninsula (figure 4 and 5). Where did all these re-used stones come from? When, and why, were they added to the building?

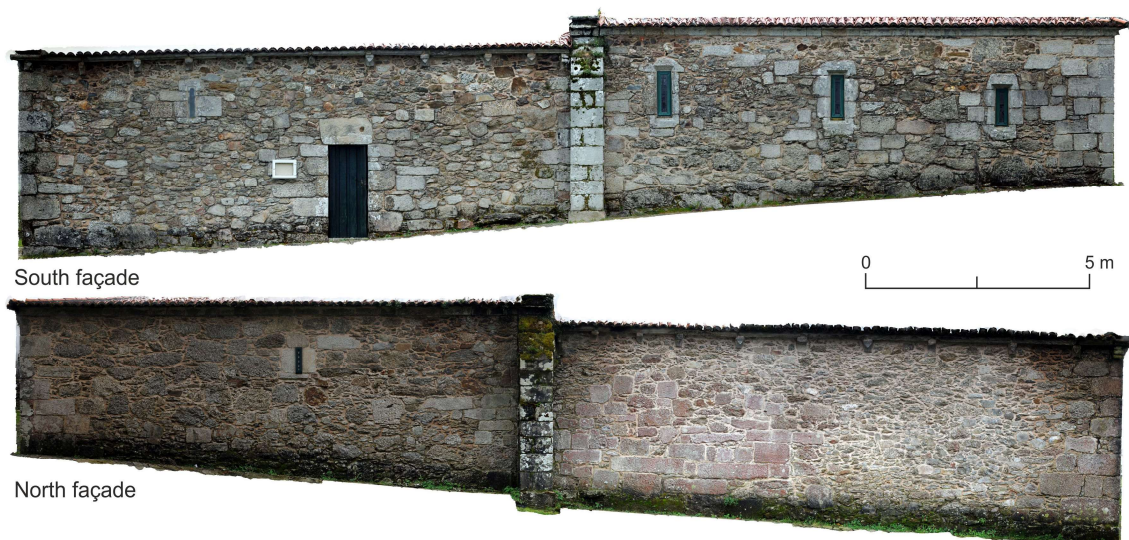
FIGURE 6

Firstly, with the aim of obtaining a correct geometric documentation of the north and south walls of the nave, as well as of the epigraph and the twin window, we decided to create a photogrammetric model of these elements using Agisoft PhotoScan Pro software. To do so, a series of specific photographs were taken, and the model was then scaled using the measurements of the building made on-site. The result was a 3D model representing the shape and look of the selected elements, with a realistic appearance (with texture, figure 6), and another version without texture that made it possible to visualise other elements, such as inscriptions or carvings.

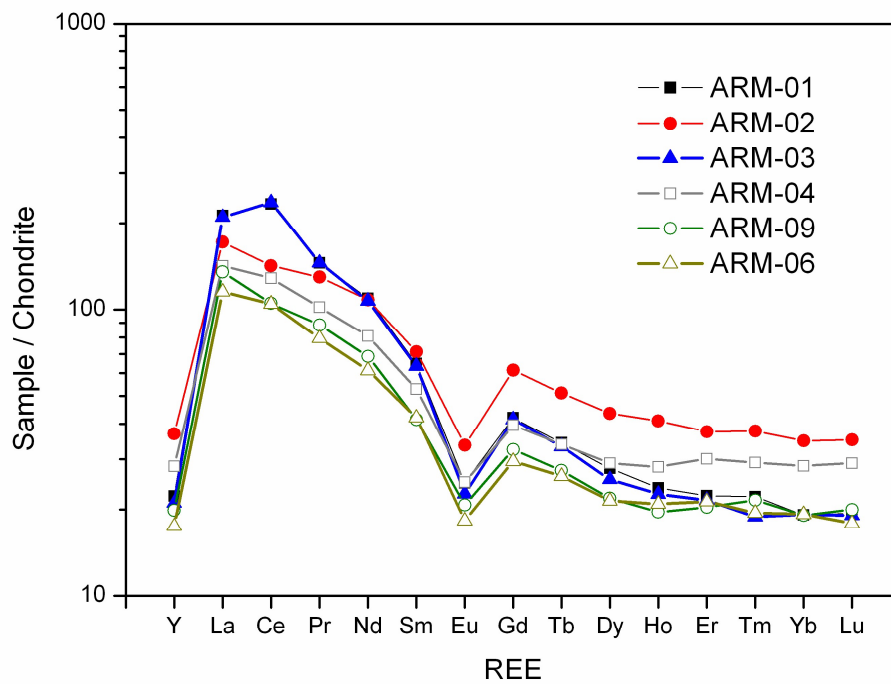
FIGURE 13

Fig. 13 Normalized REE patterns of the studied mortars and the ceramic sample. It can be observed that the pattern of samples ARM-01 and ARM-03 completely fit and also samples ARM-08 and ARM-09 (ceramic) fit with a shift observed in the ARM-08 sample

The XRF results for raw samples were very similar, revealing similar concentrations of minor and major elements in ARM-01 and ARM-03, with different concentrations in ARM-02 and ARM-08 (table 2). The concentration of these trace elements obtained by ICP-MS coincides with the XRF results (table 2). In order to verify the possible source of the samples, chondrite-normalised rare earth element (REE) patterns were used (Anders and Gravenese, 1989). This pattern is used as a chemical fingerprint to verify the possibly common origin of geological samples such as sediments, or archaeological materials such as pottery (Lipin and Mackay, 1989; Prudêncio *et al.*, 2009). In the case of the samples we studied, the chondrite-normalised REE pattern coincides fully for ARM-01 and ARM-03, while they are clearly different for samples ARM-02 and ARM-04 (figure 13). On observing other parameters, the Eu anomaly for ARM-01 and ARM-03 is similar, in the same way as the total REE and light-heavy REE ratio (LREE/HREE) (table 3), while these were different for the other samples. These values are within the range of edaphic materials observed in Europe (<http://weppi.gtk.fi/publ/foregsatlas/index.php>). On observing the REE pattern for a sample corresponding to one of the types of rocks used in the building (ARM_U06), it was found that samples ARM-09 and ARM_U06 (gneiss) coincided, and are similar to

that of sample ARM-08, although the total REE and LREE/HREE ratio, as well as the Eu anomaly, are different. This could be due to the effect of weathering on the soils used to prepare the mortars, meaning it is difficult to affirm whether these are materials of different origin. The coincidence between ARM-08 and ARM-09, which are materials that are present in the same structure, could indicate that they are contemporary. Attending to the agreement with the REE pattern of one of the studied gneiss samples (ARM_U06), it is possible that the material used for mortars ARM-02 and ARM-08 was collected in an area where the gneiss underlays the soil. This probably corresponds to the church surroundings as gneiss outcrops can be observed there (figure 16). And the geological map shows that it is located on the gneiss-rich area (figure 15).

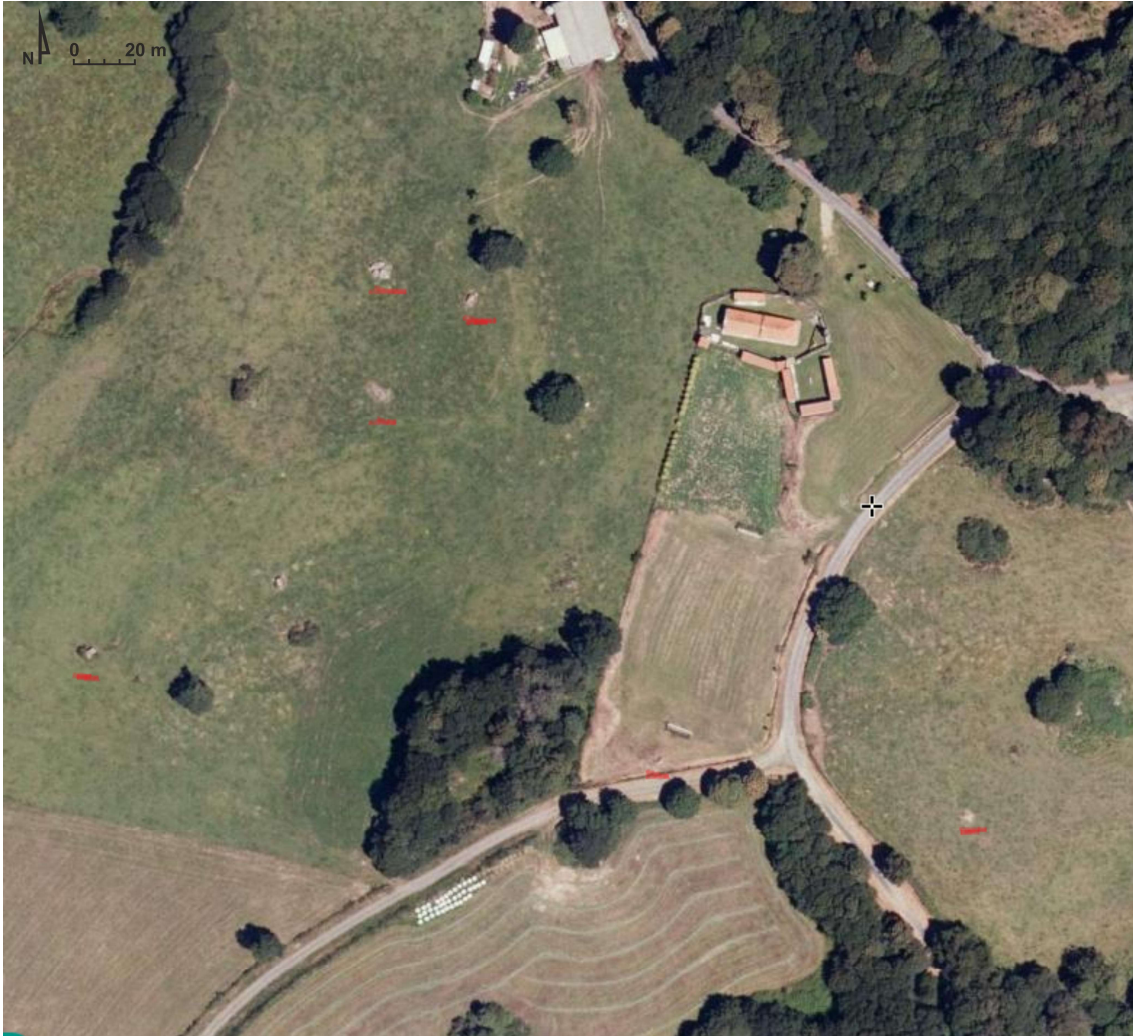
FIGURE 16

Fig. 16 Aerial view of the church of San Martiño de Armental and the nearest gneiss outcrops (red spots)

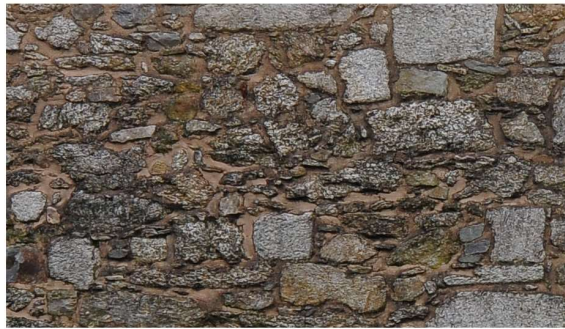
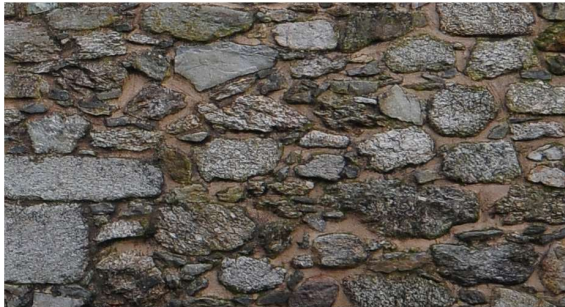
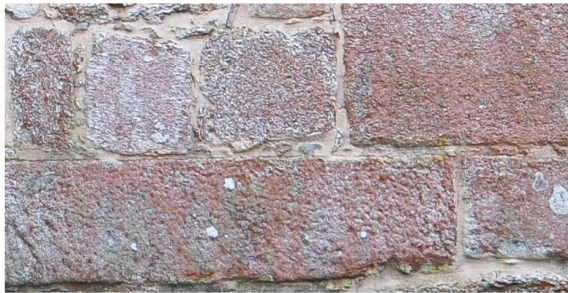
FIGURE 18

In modern times, the Romanesque building was extended, demolishing the chancel and extending the nave towards the east. Simple, economic construction techniques were also used for this new refurbishment, using locally sourced masonry that would indicate a relatively low investment on the part of those who commissioned the work (Figure 18).

**Modern times
(17th-18th centuries AD)**

**Romanesque
(ca. 1200 AD)**

**Early medieval
(9th-10th centuries AD)**
